Revision Guide for AMD Family 15h Models 10h-1Fh Processors

Publication # 48931	Revision: 3.00
Issue Date: May 2012

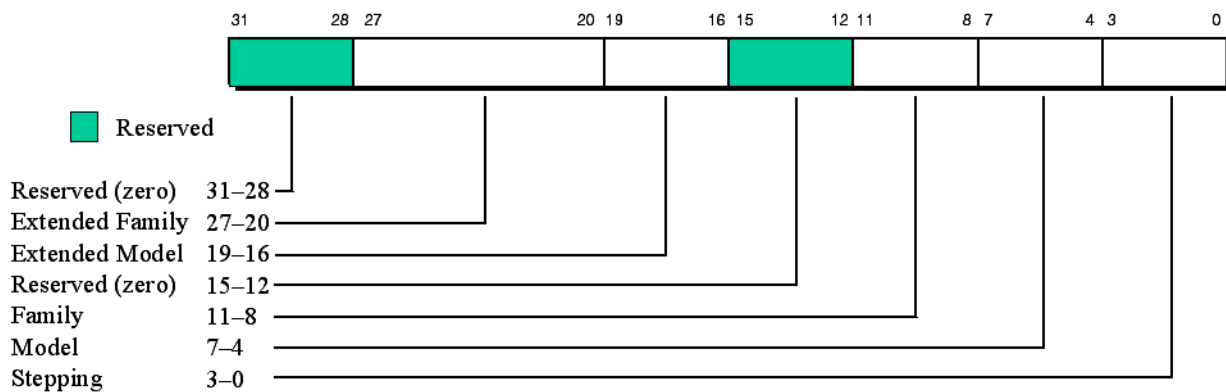
Figure 1. Format of CPUID Fn0000_0001_EAX

A processor revision is identified using a unique value that is returned in the EAX register after executing the CPUID instruction function 0000_0001h (CPUID Fn0000_0001_EAX). [Figure 1](#) shows the format of the value from CPUID Fn0000_0001_EAX. In some cases, two or more processor revisions may exist within a stepping of a processor family and are identified by a unique value in D18F4x164 Fixed Errata Register (see [D18F4x164 Fixed Errata Register](#)).
